**TESTER**

**LH 20S**

**(RESISTANCE ALARM SYSTEM)**

**OPERATING MANUAL**

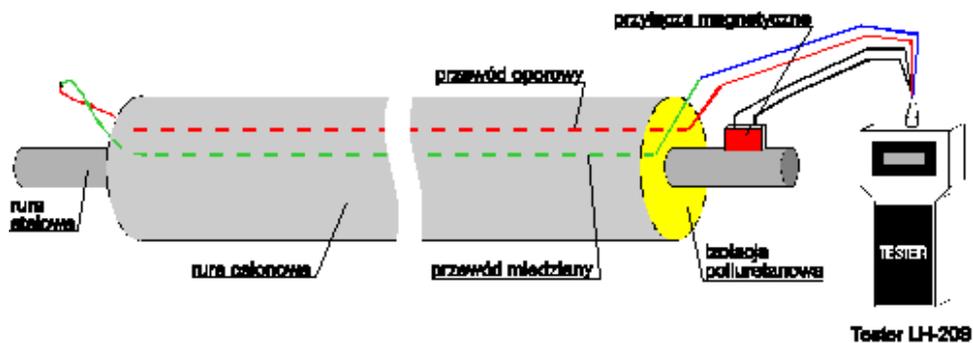
Fig. 1. Basic measurement.

After careful execution of the connection, in a manner shown in fig. 1., press and hold the START switch of an LH-20S meter. First, the display will show information regarding the device (type, serial no.), and then the values of the measurements and calculations. An indication example is shown below.

The first row of the display provides: the calculated polyurethane insulation MH moisture degree value, measured polyurethane insulation resistance value. While the second row of the alphanumeric display shows: the calculated length of the tested heating pipelines section in [m], measured alarm loop resistance value [Ω].

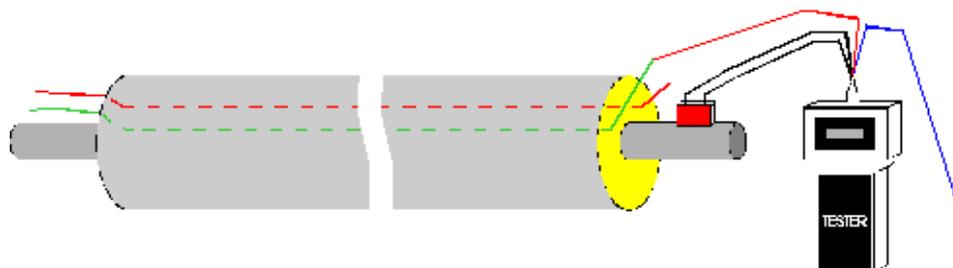
Fig. 3. Checking the condition of a copper wire insulation.

Only an LH-20S indication shown below is a confirmation of a good condition of copper wire teflon insulation.

A **Przerwana pętla** (*Interrupted loop*) message arises from the selected measurement method (no blue lead) and does not have any significance in this case. After obtaining measurement results other than the ones stated, make sure that a leak localization measurement is not burdened with a very large error. It may even turn out that determining a moisture location is impossible. Such is the case when the MH parameter reaches low values or instead of the measurement results regarding the resistance of insulation between a copper wire and a steel pipe, a **Zwarcie** (*Shorting*) message appears.

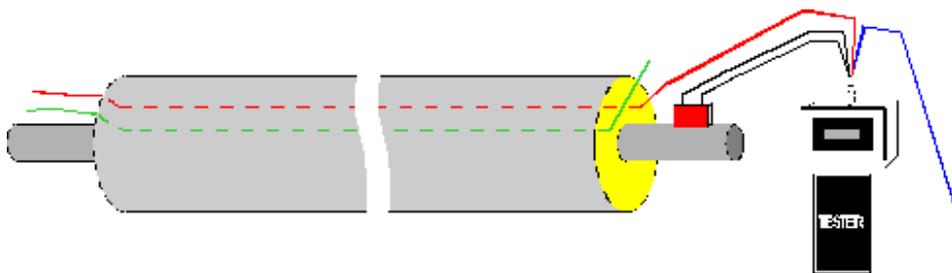
*Fig. 4. Checking the degree of moisture between a resistance wire and a steel pipe. Shorting detection*

*In a similar manner, but for a completely different purpose, the aforementioned auxiliary measurement for an alarm loop resistance wire is conducted. A measurement system concept is stated in figure 4.*

*The primary reason for taking this measurement shall be further explained in the Practical advice chapter. At this point, it should be added that it is sometime performed somewhat spontaneously, after detecting moisture between a copper wire and a steel pipe within a tested heating pipelines. The confirmation of the detected state for both wire types is sought after at that*

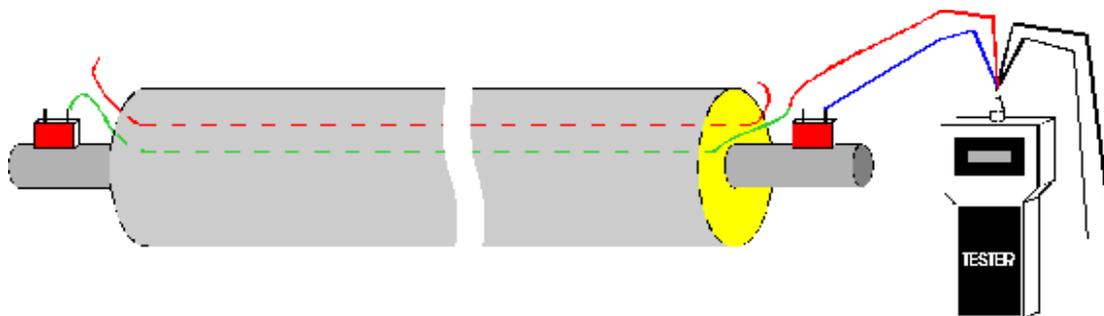
*Fig. 5. Checking the copper wire condition in terms of mechanical damage.*

Gap/s in an alarm loop may be localized after proper discernment and preparation of measurement conditions. The testing should be commenced with checking the condition of a copper wire, since it is most vulnerable to this type of damage. Fig. 5 shows the concept of a proper measuring system.

As can be seen, with the help of a magnetic connector, one end of a copper wire is shorted with a steel pipe. The red and blue leads of an LH-20S meter are connected to the other end and the pipe. One can also use a magnetic connector to achieve a connection with the pipe. Next, the

measurement is performed. If the second row displays a **Przerwana Pętla** (*Interrupted Loop*) or **HI** message or measurement result values changing over a broad range, it means that an alarm loop copper wire is damaged. The gap is localized with the use of a reflectometer. Whereas measurement results within a range of  $0 \div 11\text{m}$  and, respectively,  $0 \div 60\Omega$  are a confirmation of a good condition of the copper wire. Results depend on the length of the tested wire ( $0.036 \Omega/\text{m}$ ) and the resistance of contacts between magnetic connectors and a steel pipe.

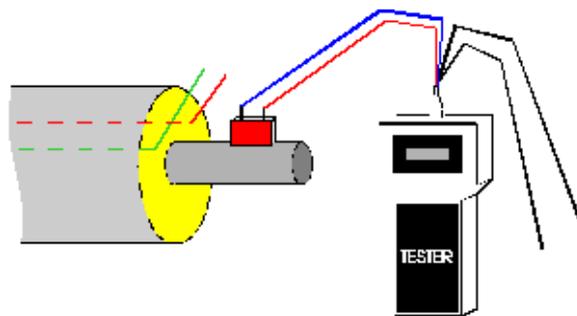
*Fig. 6. Checking the quality of an electric contact between a magnetic connector and a carrier pipe.*

*A confirmation of a good contact is displaying the following measurement results:  $0\text{m}$ ,  $0 \div 3\Omega$ . A resistance wire is checked regardless of the copper wire test result. Case of damaging (rupture) of both wire are not that rare. A relevant measurement system concept is stated in figure 7.*

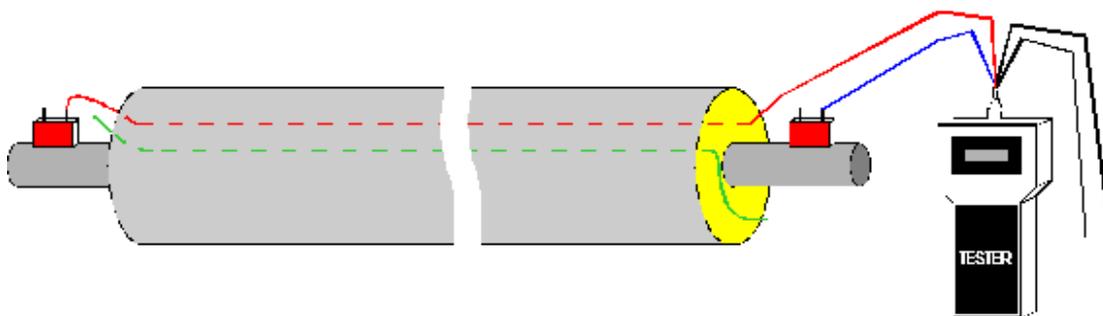
*Fig. 7. Checking the resistance wire condition in terms of mechanical damage.*

*In the first search phase, a resistance wire is shorted with a steel pipe at one end of an alarm loop. It can be done, for example, in a junction box or as shown in figure 7. Next, the blue and red leads of the LH-20S meter are connected with the second end of the wire and the magnetic connector shorted with a steel pipe. The measurement result values confirming a good condition*

of the resistance wire depend on its length ( $5.7\Omega/m$ ) and the resistance of contacts between magnetic connectors and the steel pipe. If the connections are executed carefully, just the length and resistance values of the tested wire are displayed. Whereas the appearance of the **Przerwana Petla** (Interrupted Loop) or **HI** or measurement results values changing over a broad range mean that an alarm loop resistance wire is damaged. The type of the displayed message or the measurement result presentation manner define the type of the damage. (See examples of indications with comments). If a gap is detected, further actions depend on the structure of the tested heating pipelines. If it does not have any branches - a reflectometer is used to locate failures. In the case of branches, the damaged wire section shall be separated. For this purpose, the alarm loop connections in all junction boxes are opened. Next, the condition of each section is checked, almost directly following the description above and figure 7. The difference is that in the case of branches, an extension of a resistance wire cannot be a copper wire. In such a case, the end of this wire contacts the pipe.
